# FULL RESERVE STUDY

## Mainlands of Tamarac by the Gulf Unit Six Association, Inc.

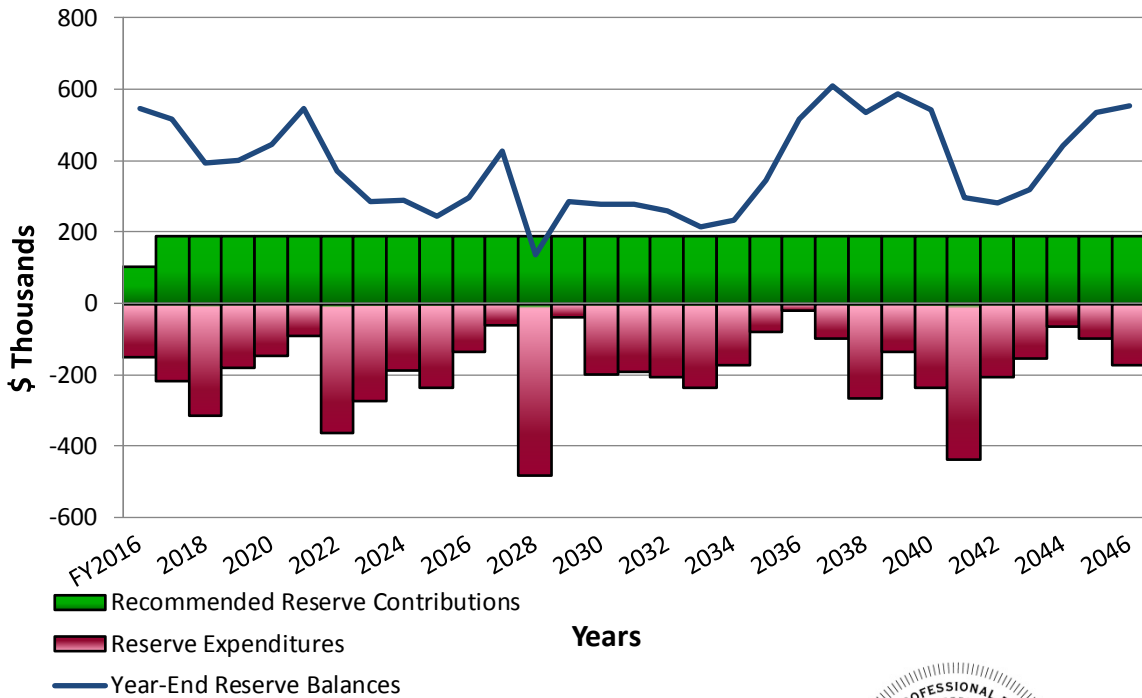
Respectfully submitted on August 16, 2016 by  
RESERVE ADVISORS, INC.

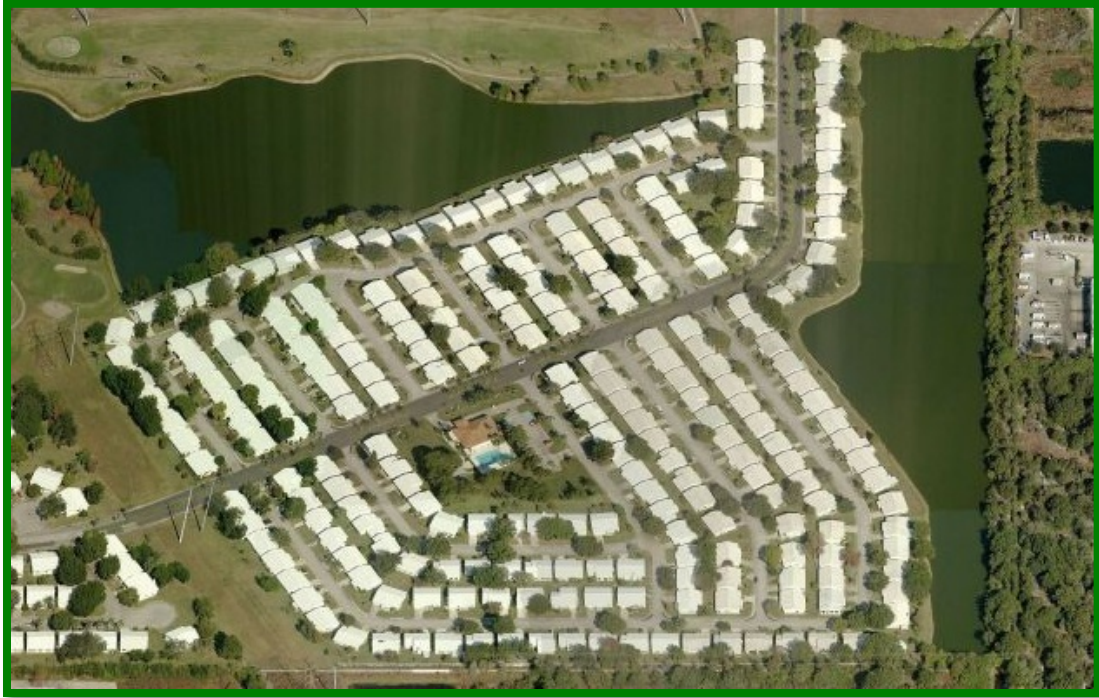
Mainlands of Tamarac by the Gulf Unit Six Association, Inc. is a planned unit development that consists of 237 single family homes. The exteriors of the buildings comprise stucco walls and concrete tile roofs. The development was built from 1979 to 1986 and contains asphalt pavement streets, concrete flatwork, two ponds, perimeter walls, shuffleboard courts and a clubhouse and pool. We identify 29 major reserve components that are likely to require capital repair or replacement during the next 30 years.

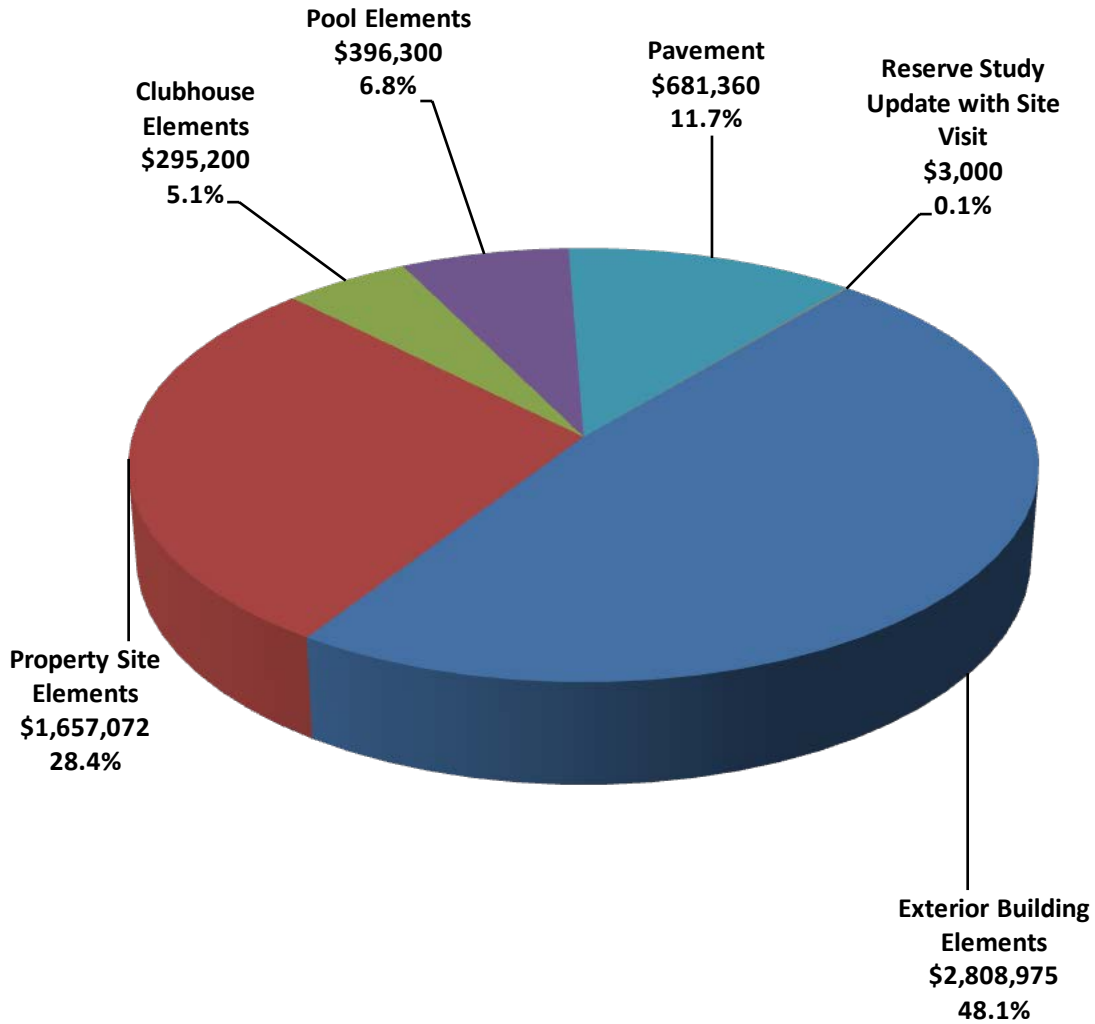
## RESERVE EXPENDITURES

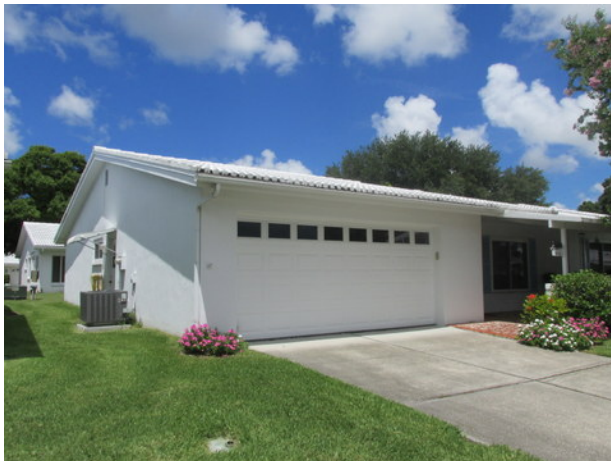
Front elevation overview

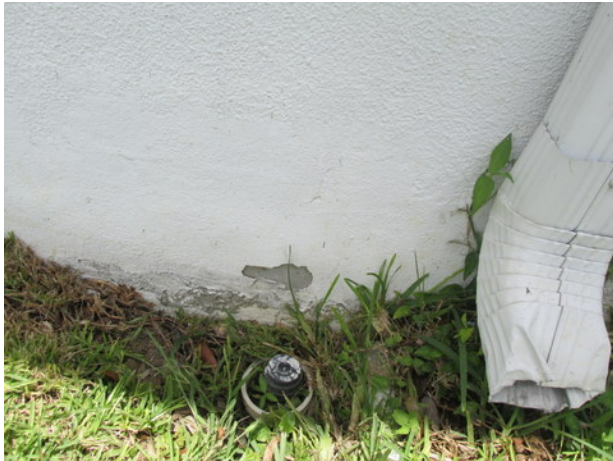
**Stucco finish deterioration**

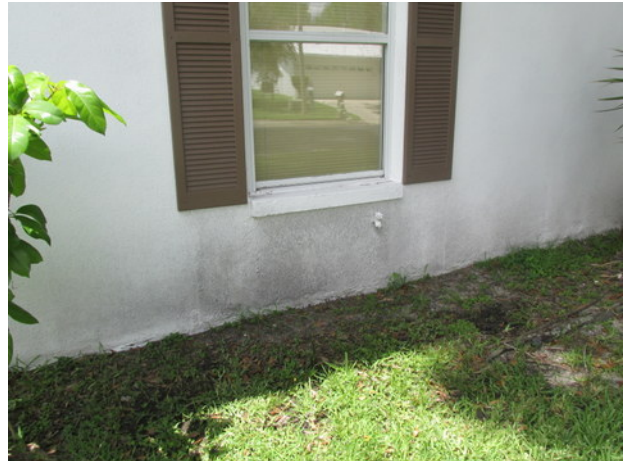
**Stucco wall stain**

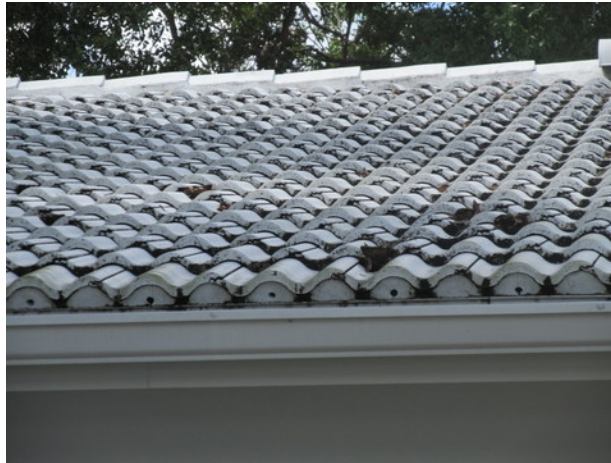
**Concrete tile roof with biological growth**

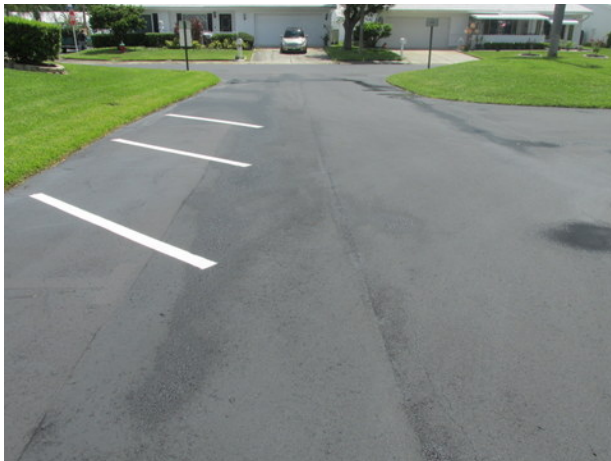
**Clubhouse parking area pavement**

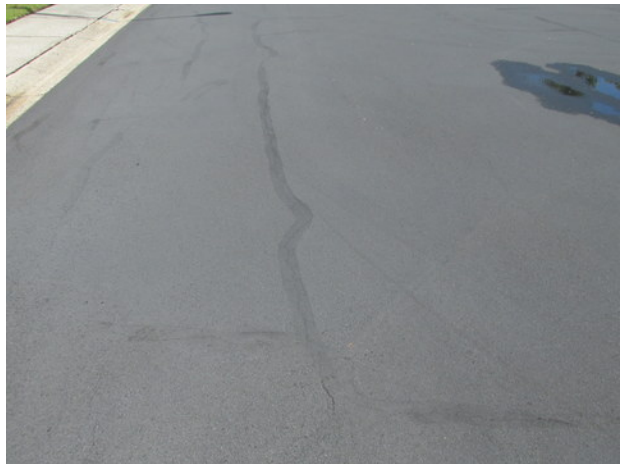
**Previous crack repair**

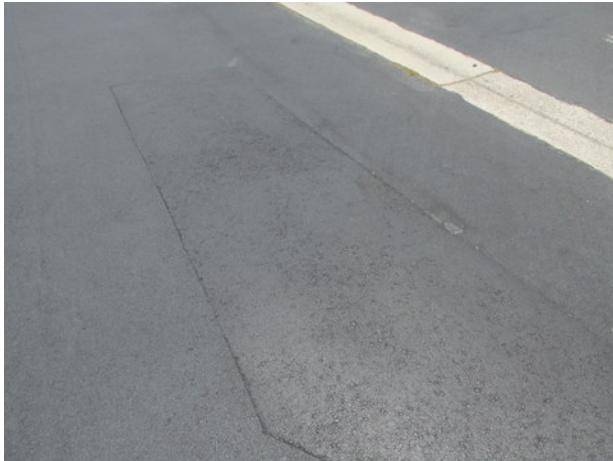
**Previous pavement patch**

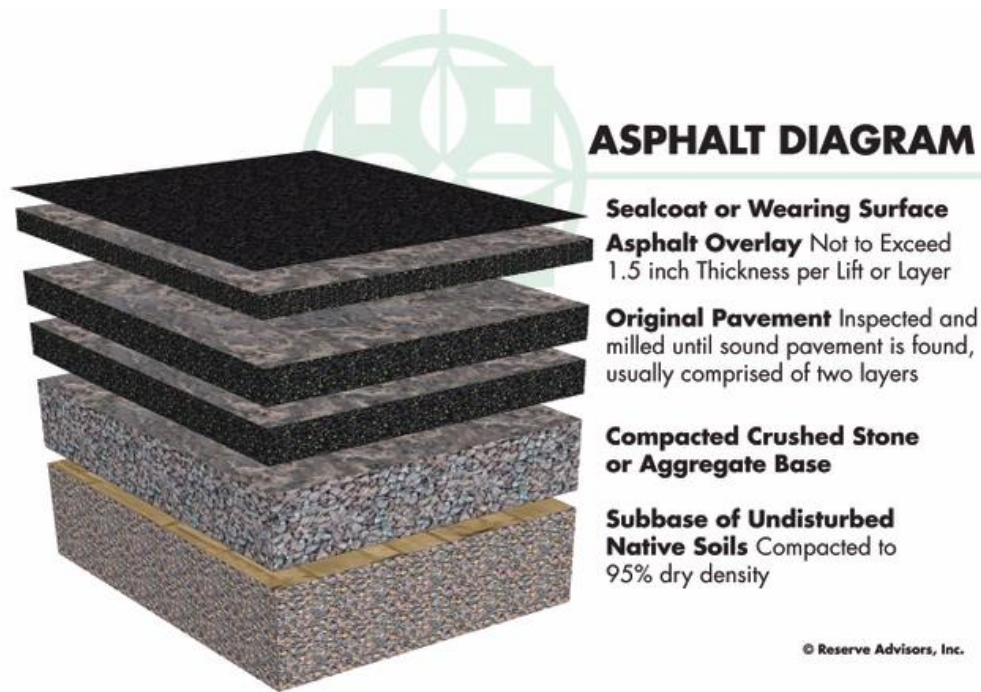
Components of asphalt pavement include native soil, aggregate and asphalt. First the contractor creates a base course of aggregate or crushed stone and native soil. The base course is individually compacted to ninety-five percent (95%) dry density prior to the application of the asphalt. Compaction assures a stable base for the asphalt that reduces the possibility of settlement. For street systems, the initial installation of asphalt uses at least two lifts, or two separate applications of asphalt, over the base course. The first lift is the binder course. The second lift is the wearing course. The wearing course comprises a finer aggregate for a smoother more watertight finish. The following diagram depicts these components:

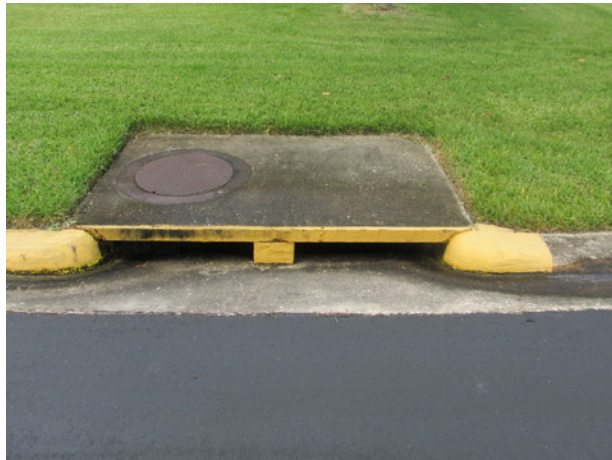
**Typical catch basin**

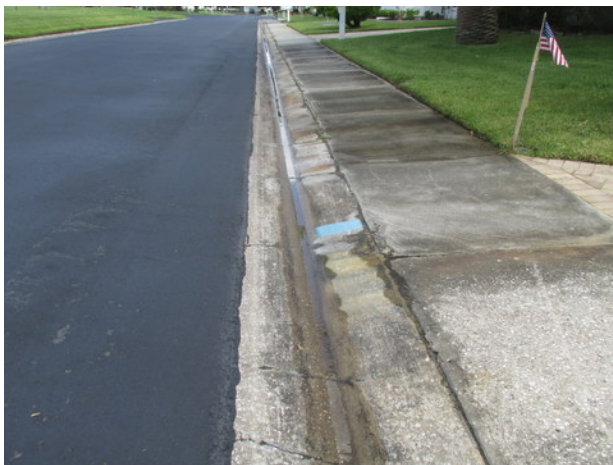
**Concrete gutter overview**

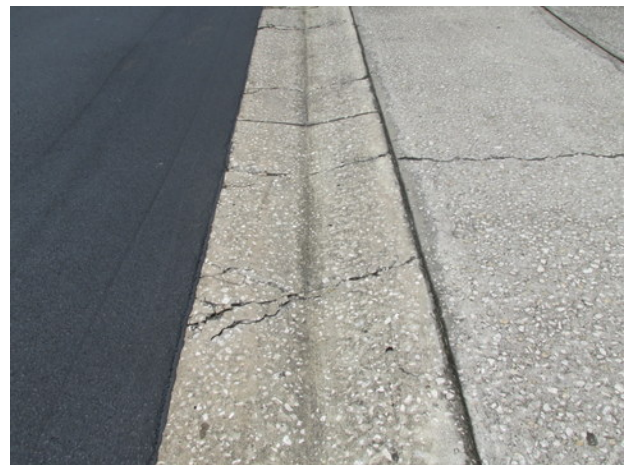
**Concrete gutter overview with typical cracks**

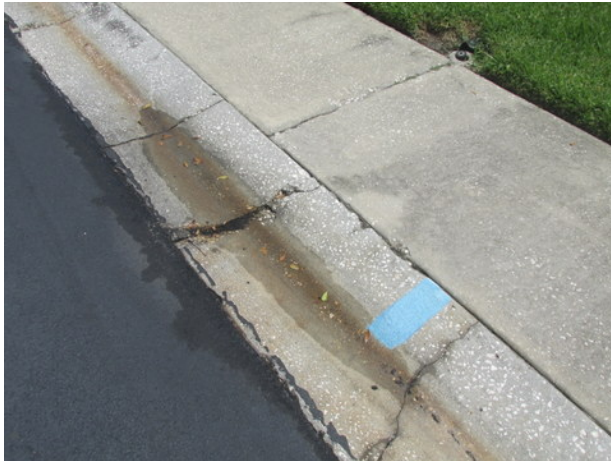
**Typical concrete gutter cracks**

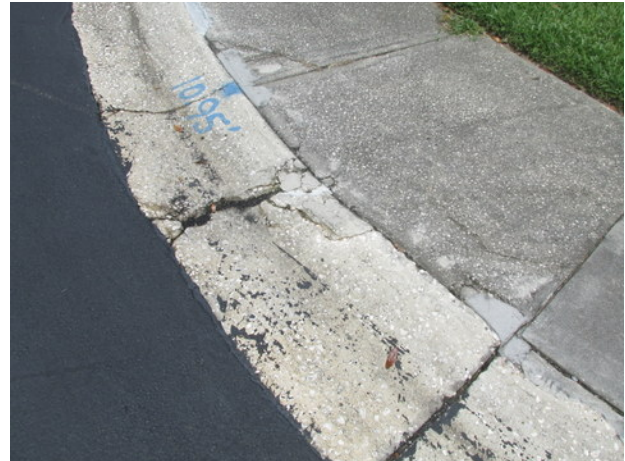
**Concrete gutter damage**

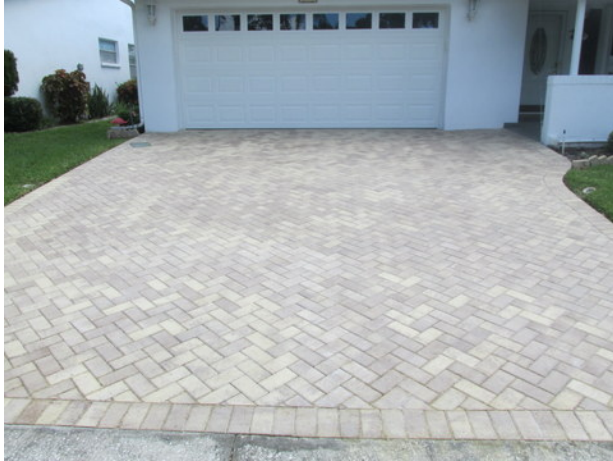
**Paver driveway (Homeowner maintained)**

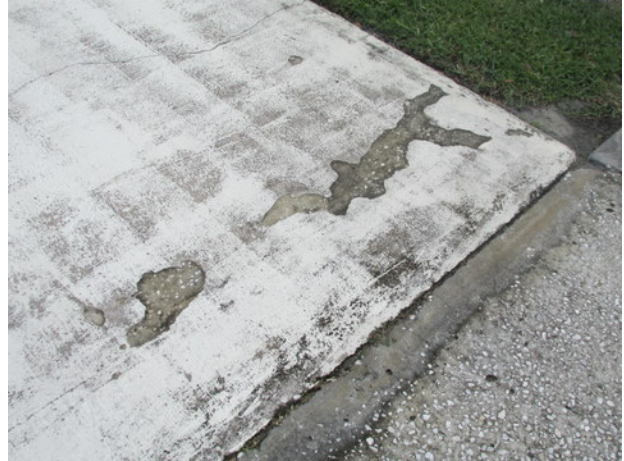
**Concrete driveway spalling at 3645 91<sup>st</sup> Avenue**

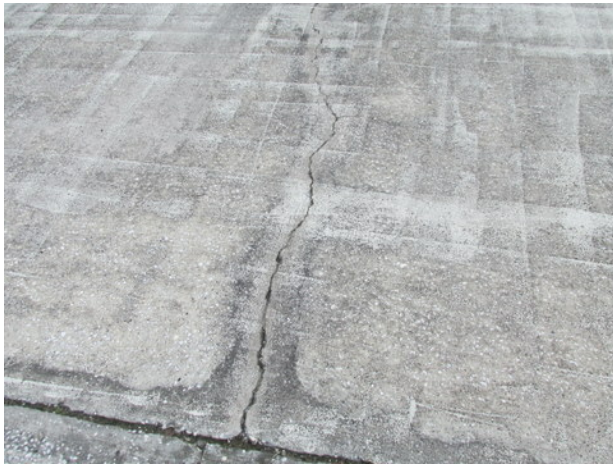
**Driveway crack at 9145 37<sup>th</sup> Street**

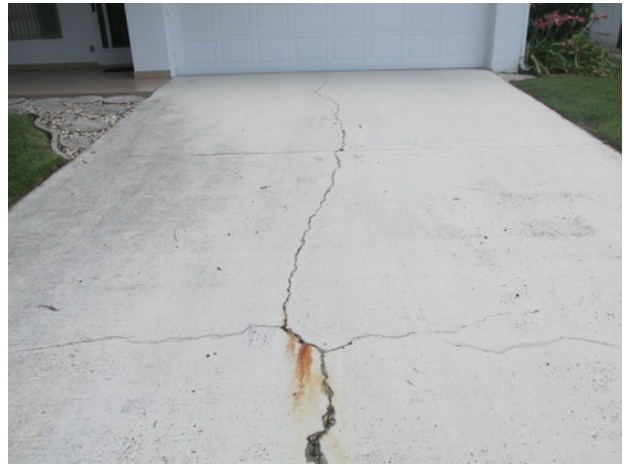
**3635 91<sup>st</sup> Avenue**

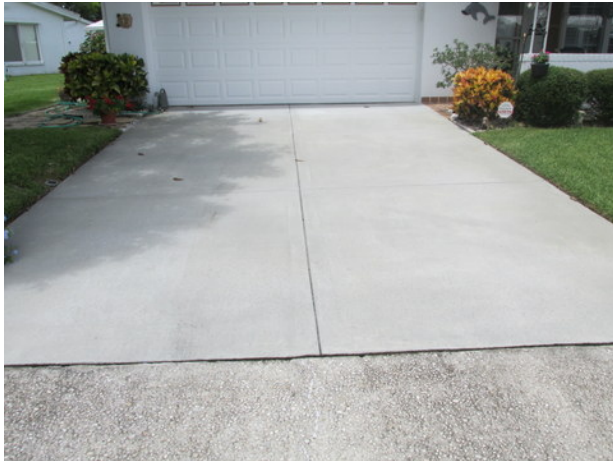
**Replaced concrete driveway**

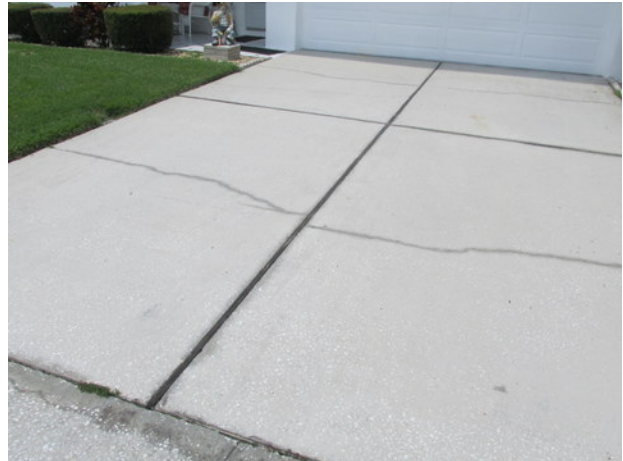
**Typical concrete driveway cracks**

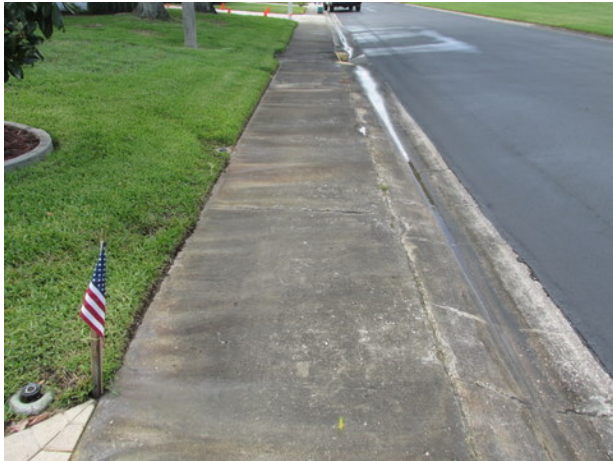
**Concrete sidewalk overview**

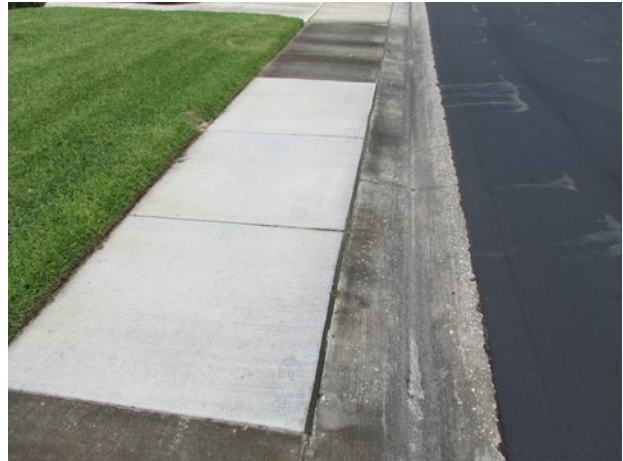
**Replaced sidewalk section**

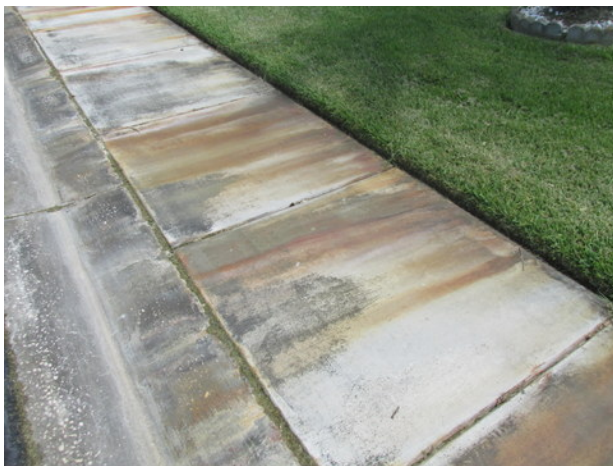
**Concrete sidewalk staining**

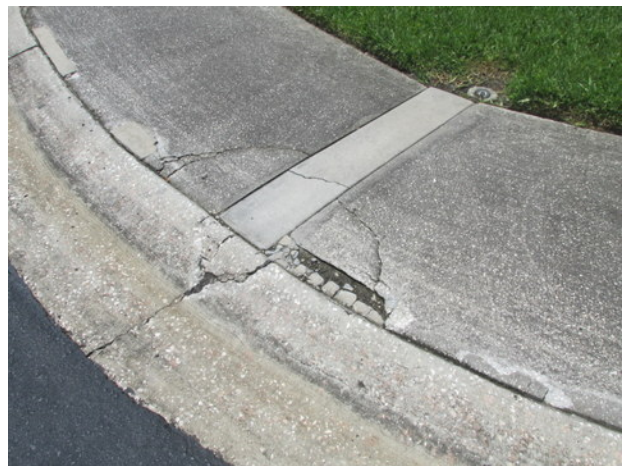
**Sidewalk edge deterioration**

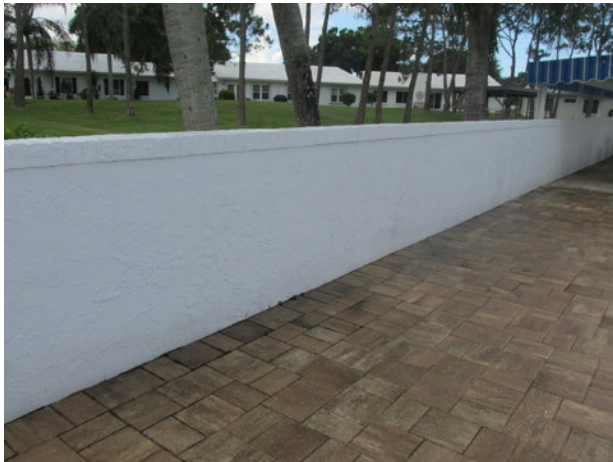
**Stucco wall at pool perimeter**

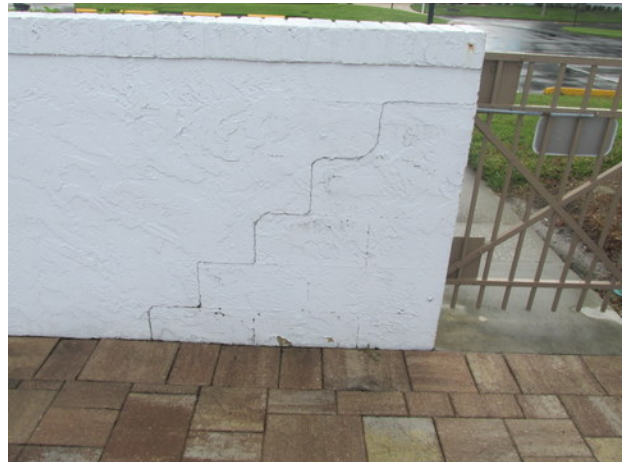
**Step cracks at pool perimeter wall**

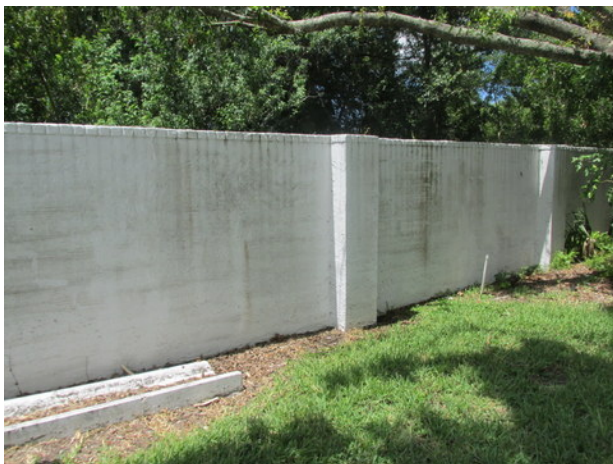
**Stucco wall at south perimeter**

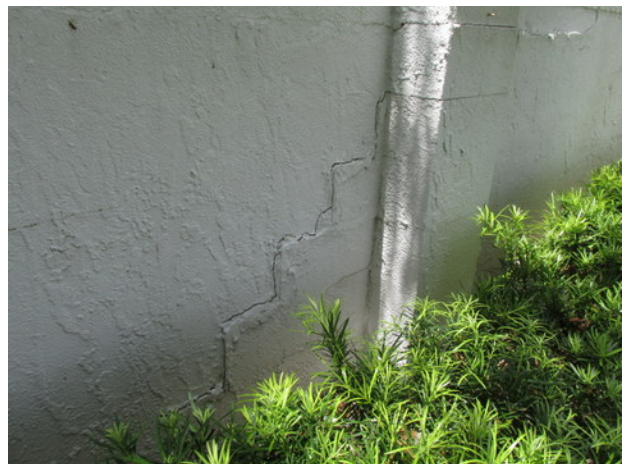
**Step cracks at south perimeter wall**

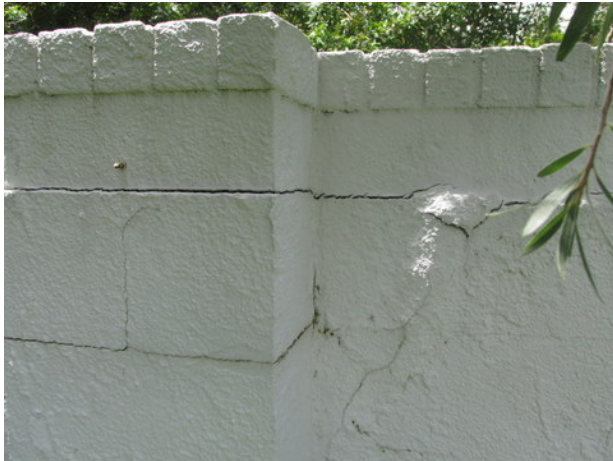
**Severe stucco cracks**

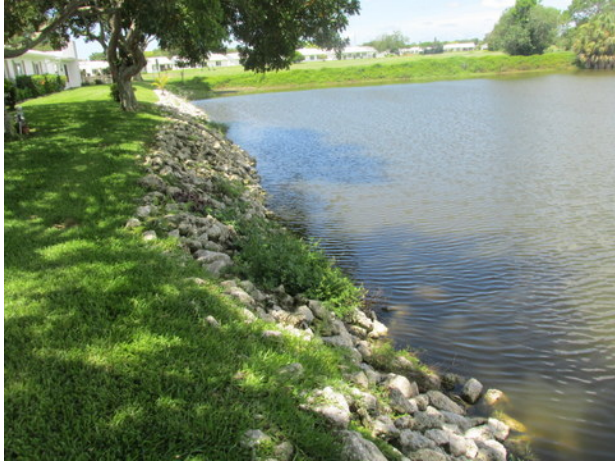
**Rip rap shoreline at north pond**

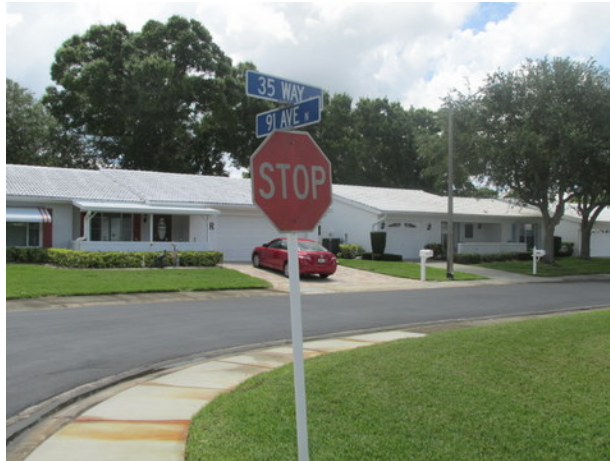
**Traffic management sign**

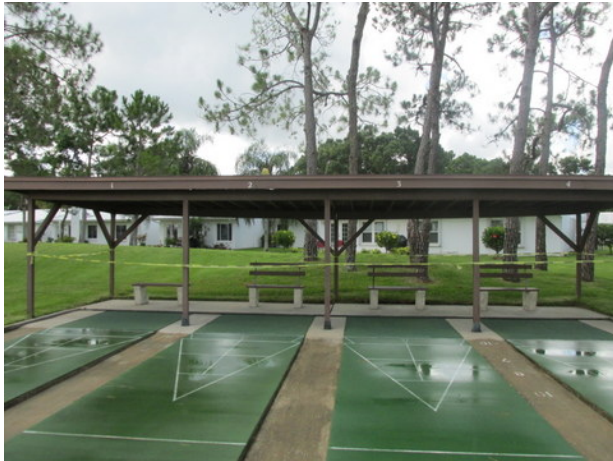
**Wood Pavilions, Shuffleboard Courts** - The Association maintains two wood pavilions located at the shuffleboard courts. The pavilions are original and in fair to poor overall condition. Management and the Board inform us that the pavilions are currently a safety issue and are in need of replacement.

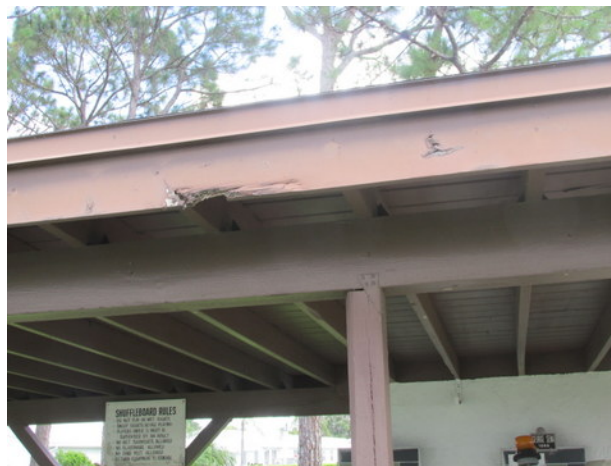
**Deteriorated wood components**

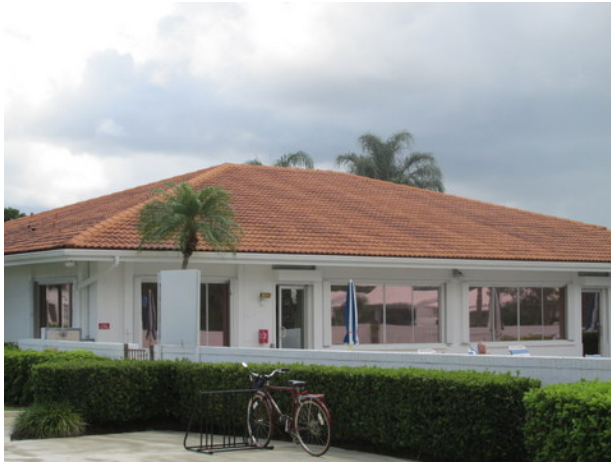
## Clubhouse Elements

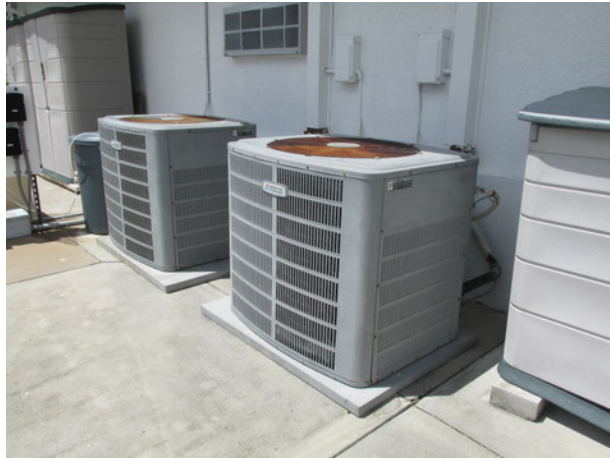
#### **Split system air condensing units**

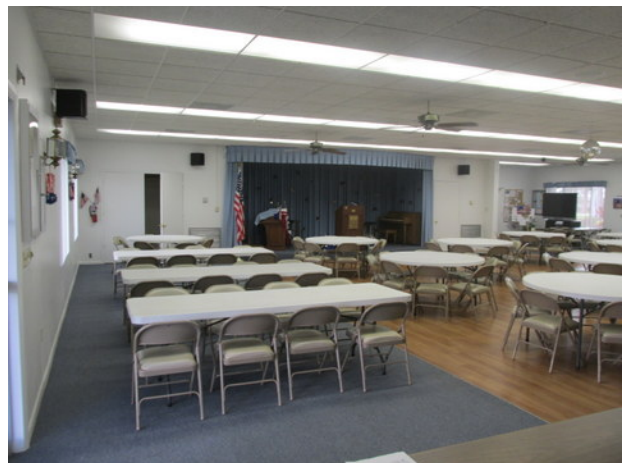
**Clubhouse interior overview**

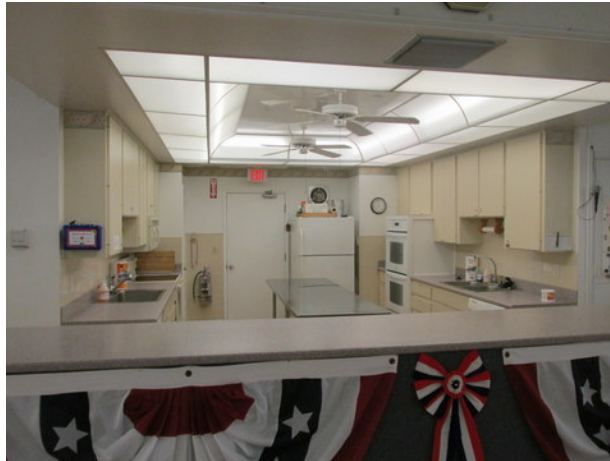
**Kitchen overview**

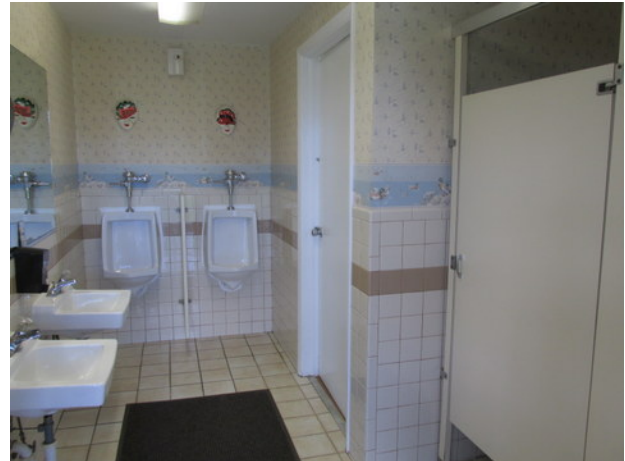
**Rest room overview**

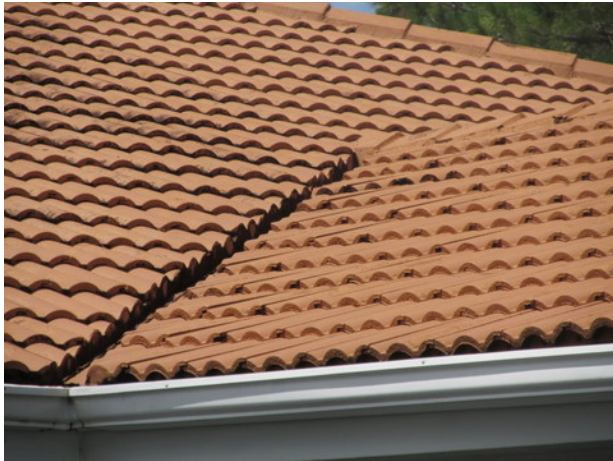
**Clubhouse roof overview**

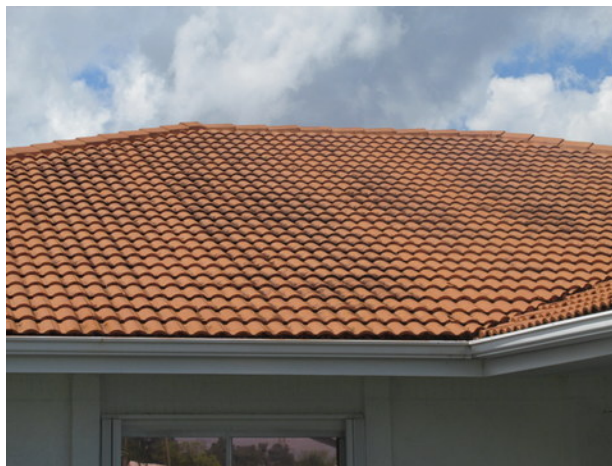
**Clubhouse roof overview**

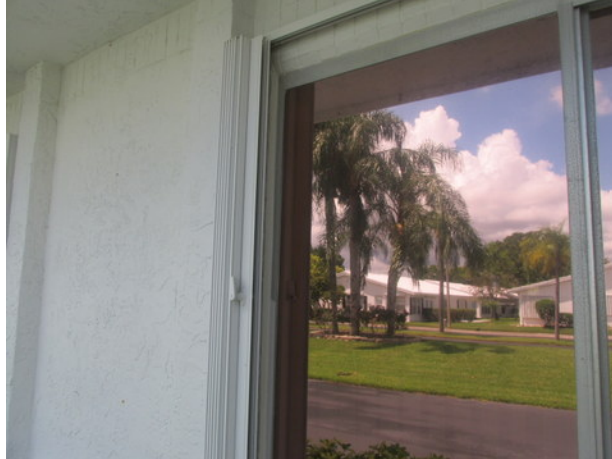
The Association should anticipate a useful life of up to 30 years for these types of hurricane shutters. We recommend the Association budget for replacement by 2023. We depict this information on Line Item 5.700 of *Reserve Expenditures*.

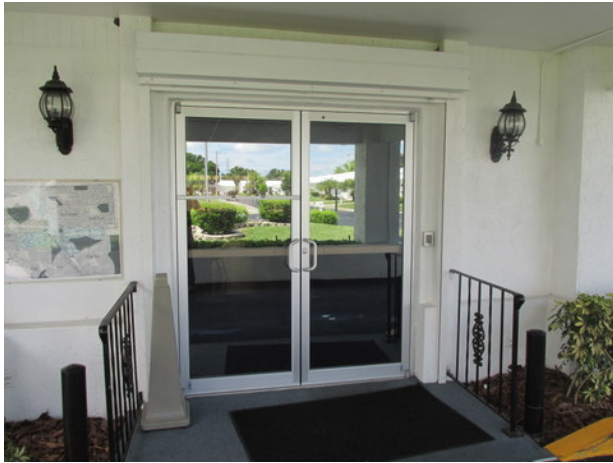
**Clubhouse front entrance door**

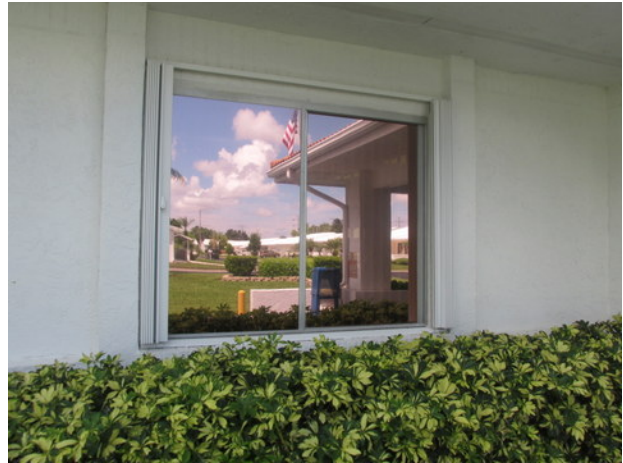
**Clubhouse window**

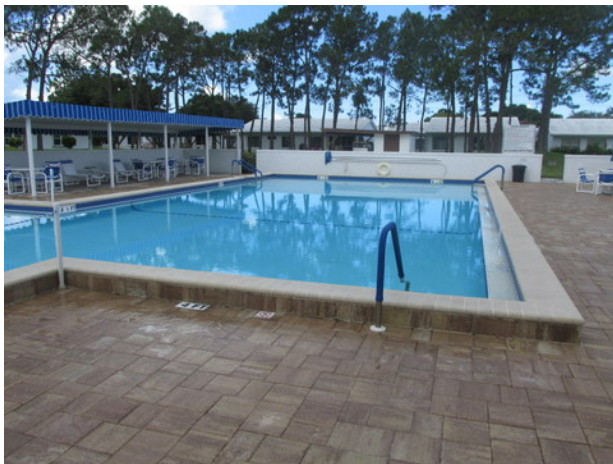
**Pool area overview**

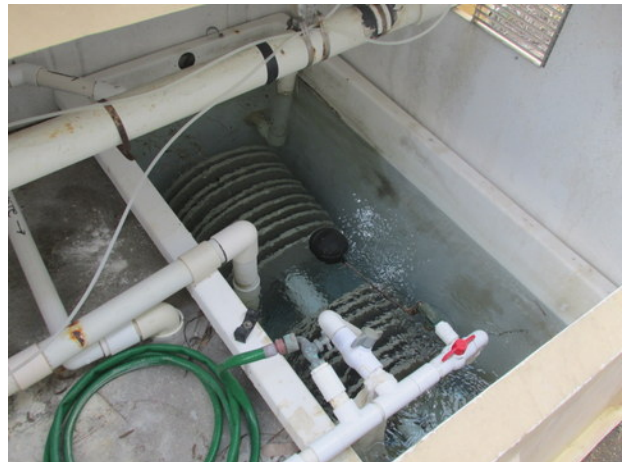
**Pool mechanical equipment**

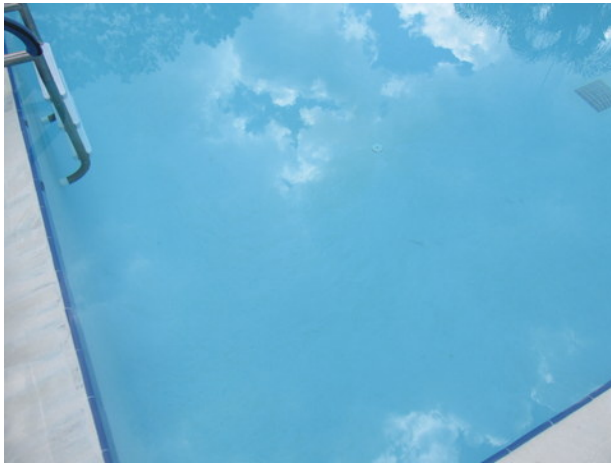
**Pool plaster finish**

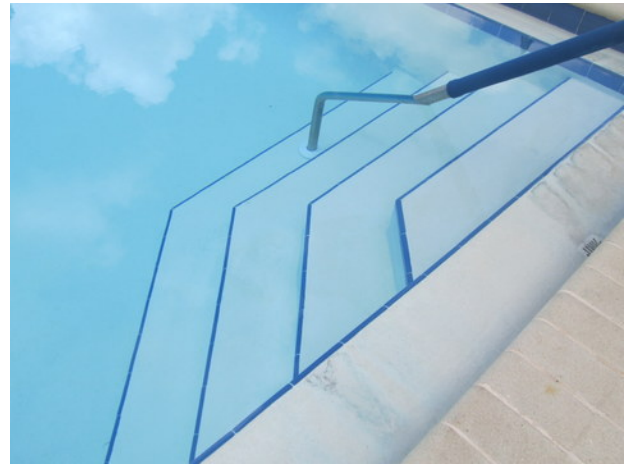
**Pool plaster finish**

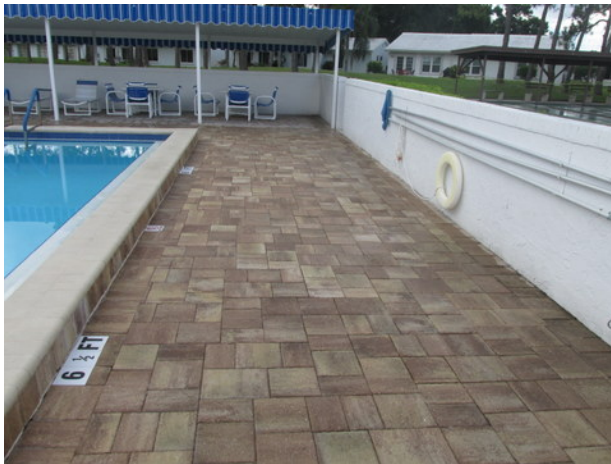
**Structure and Deck** - The concrete pool structure comprises approximately 1,900 square feet of horizontal surface area. The structure is original and visually appears in good condition. The concrete floor and walls have a plaster finish. This finish makes it difficult to thoroughly inspect the concrete structure during a noninvasive visual inspection. The surrounding deck comprises approximately 3,900 square feet of masonry pavers and is in good condition at an age of three years.

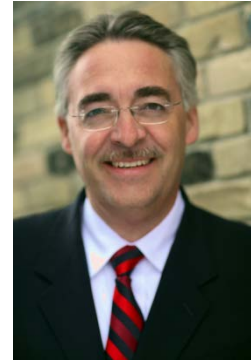
**PRIOR RELEVANT EXPERIENCE**
